| Service Bulletin |
| #SB1019 |

| Issue Date: | October 30, 2019 |
|---|---|
| Subject: | SpectroLink upgrade to internal electronics board for improved robustness against voltage transients. |
| Affected Product(s): | SpectroLink Integration Box used with SX Series Searchlight Systems. |

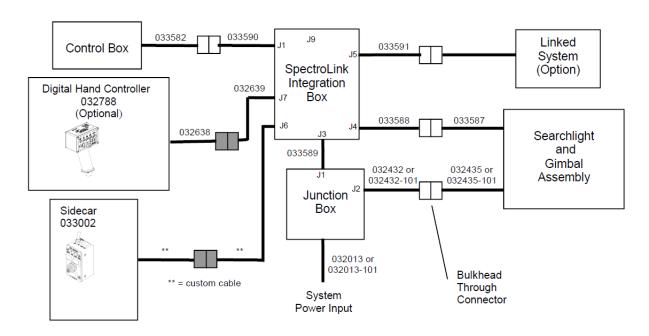
Figure 1: System Layout

- 1. Locate the SpectroLink Box on your aircraft by referring to your installation documentation package. If you do not have this data available, locate the searchlight system Junction Box (J-Box) and follow the cable harness that runs from the J-Box J1 connector to the SpectroLink Box J3 Connector, as shown in figure 1. The SpectroLink Box is sometimes located directly on top of the Junction Box, as shown in figure 2.
- 2. Locate the name plate on the SpectroLink Box, as noted in figure 3.
- 3. Note items identified in figure 3.
- 4. Contact Spectrolab Customer Service to verify if this Service Bulletin is applicable.
