**SX-16 Nightsun® Searchlight**  
**Safety and Service Bulletin # SL 0899-01**

**Subject: Gimbal Arm Corrosion**

**Bulletin # SL0899-01A**  
**SX-16 and SX-5 GIMBAL INSPECTION , FINISH TOUCH-UP INSTRUCTIONS**  
**and LIFE LIMITS**

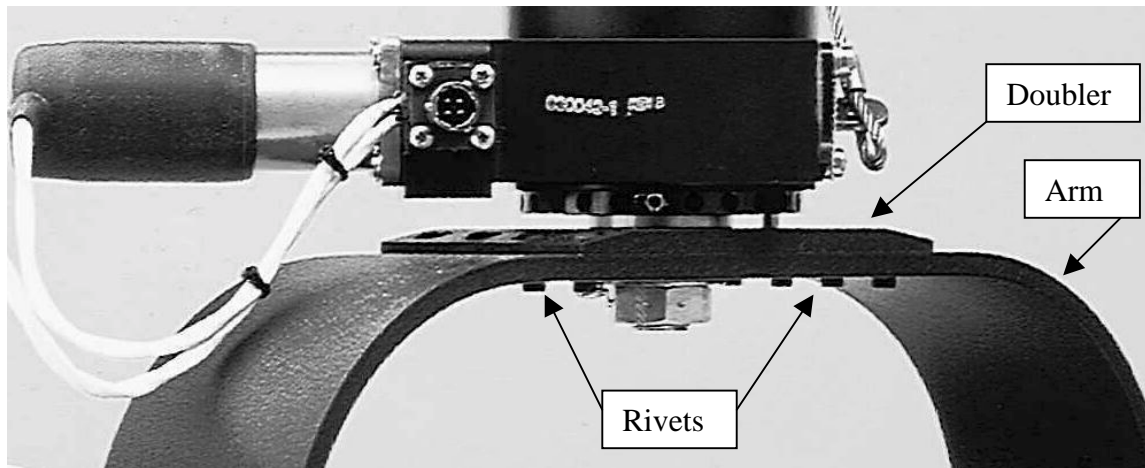
*Figure 1.* Upper portion of gimbal arm with doubler and rivets identified. See text for inspection procedure and criteria.

- 1.2.3.** In a well lighted area, examine the entire gimbal arm for signs of cracks, corrosion and chipped or peeling paint. Pay particular attention to the area of the doubler and the rivets, indicated in *Figure 1*. This inspection must be carried out by a qualified airframe mechanic trained in the visual inspection of rivets and mechanical structures. If any cracks or loose or broken rivets are found, the arm must be replaced.

- 1.2.4.** Continue the inspection using a hand held 5x to 10x magnifier. If any corrosion spots were identified with the unaided eye, examine them under magnification to determine their extent. If they are surface level only, they may be cleaned off and painted per **Section 2 - TOUCH-UP PROCEDURE (below)**. Inspect for evidence of separation or peeling of the aluminum. Corrosion and / or pitting which is more than .010" (0.25 mm) deep or over 0.125" (3.2 mm) in diameter should not be repaired. In this instance, the gimbal arm must be replaced.

- 1.2.5.** Take a 0.005" x 1/2" wide (0.125 mm x 10 mm wide) feeler gauge and try to insert it between each of the ends of the doubler and the gimbal arm. If it can be inserted over 0.25" (6 mm), this indicates there is separation between the gimbal arm and the doubler, and the arm assembly must be replaced.
