# <u>SX-16 Searchlight</u> <u>Cooling Enhancements</u> <u>Safety and Service Bulletin # SL 0214</u>

Date: 12/15/14

All SX-16 Nightsun® Searchlights with existing rubber baffling on the Front Window and standard Cooling Blower airflow direction

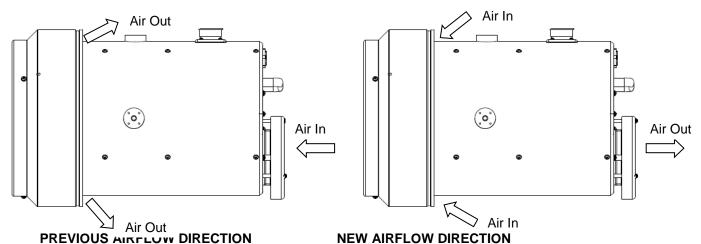
Previously, the air to cool the Lamp entered the rear of the Searchlight and exhausted the heat generated by the Lamp and other internal components through the Front Window Baffle (left below). This was achieved by the original rotation direction of the Cooling Blower. By reversing the air flow direction, the air now enters through the Searchlight Front Window Baffle and the heat is exhausted through the Cooling Blower Cover on the Rear Cover of the Searchlight (right below). This update as well as the Front Window Baffle material change described in the next paragraph, contributes to improved cooling.

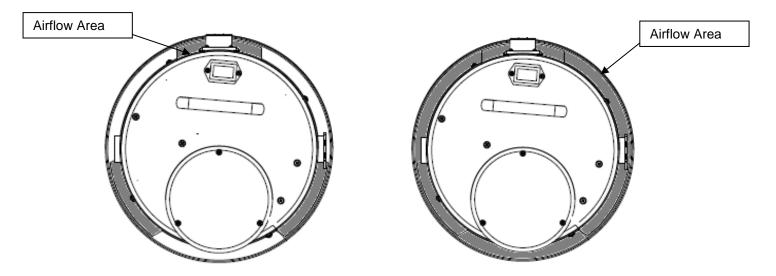
The standard Baffle bonded to the Front Window is made of heavy rubber which allows air to flow through three openings. This Baffle is recommended to be changed to a filter foam type Baffle to allow air to flow uniformly throughout the entire perimeter of the Front Window. The illustration below compares the rubber Baffle (left) to the filter foam type Baffle (right) looking at the rear of the Searchlight with the shaded areas where air can flow. The figure on the right shows that air will flow evenly around the Searchlight as opposed to three vent areas.

In addition to allowing more airflow, another feature of the foam baffle is that it prevents particles such as dirt, sand, insects and other types of debris from entering the Searchlight.
