**Nightsun<sup>®</sup> XP Searchlight**  
**Safety and Service Bulletin # SL 0810-01**

Amendment # 3

Date:09/27/2010

**Subject: Gimbal Azimuth Top Hex Nut**

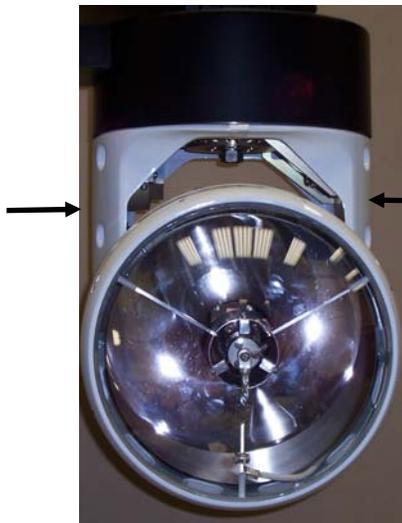
Gap should not appear when pressure is applied on the Side Covers when trying to create side-to-side motion from either side.

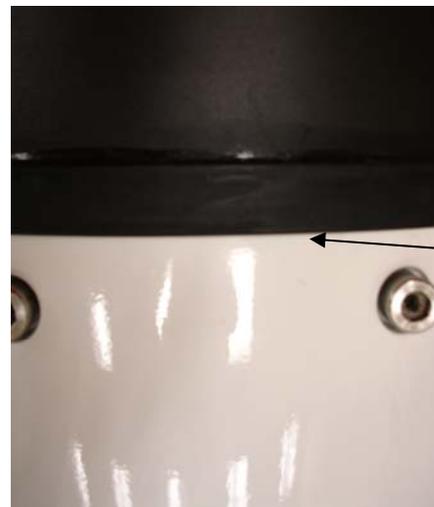
Rubber edging should be making contact with Side Cover and a gap should not be present here
