SX-5 Starburst Searchlight *Service Bulletin #SL0110*

Subject: This Bulletin is to alert owners and operators of SX-5 searchlights of potential xenon lamp overheating.

All SX-5 Starburst Searchlight Assemblies

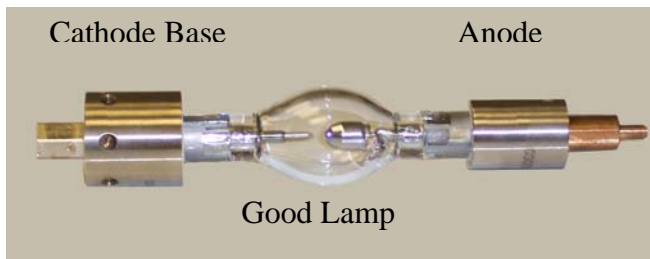
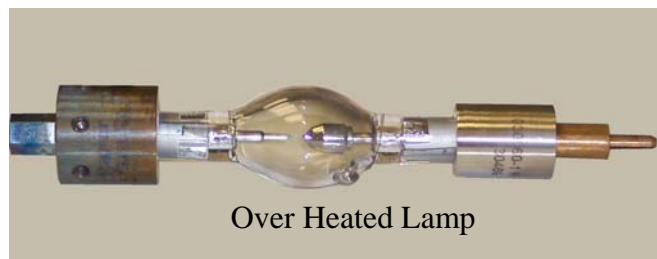
Inspection of the lamp cathode can detect this problem. On a good lamp, the anode and the cathode are the same color as opposed to the overheating results in a blue discoloration on the cathode base. This is a sign of a lack of airflow for cooling.

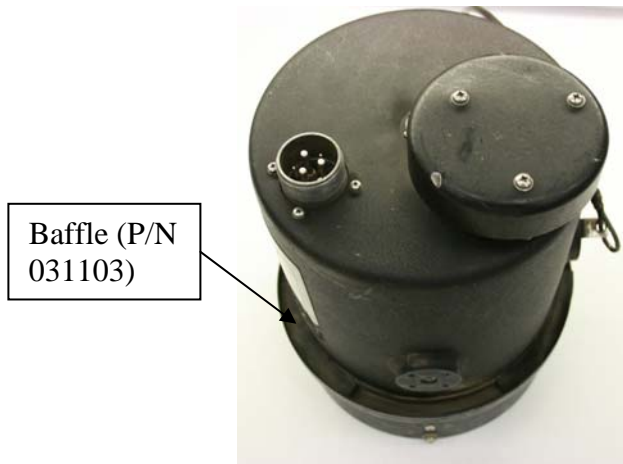
1. Locate the Baffle between the Front Window Assembly and the Searchlight housing.

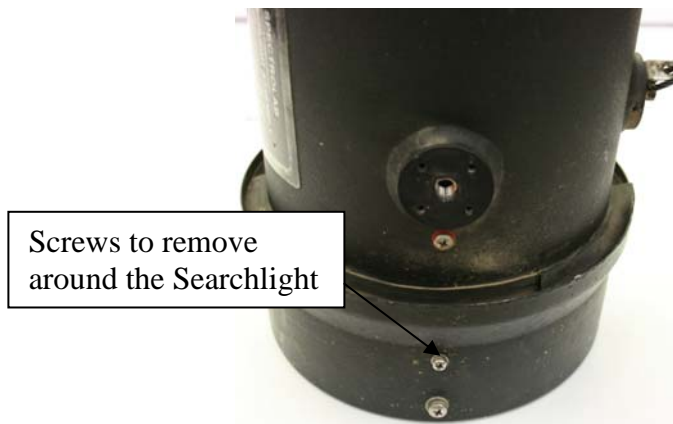
2. Remove 3 screws around the Front Window Assembly.

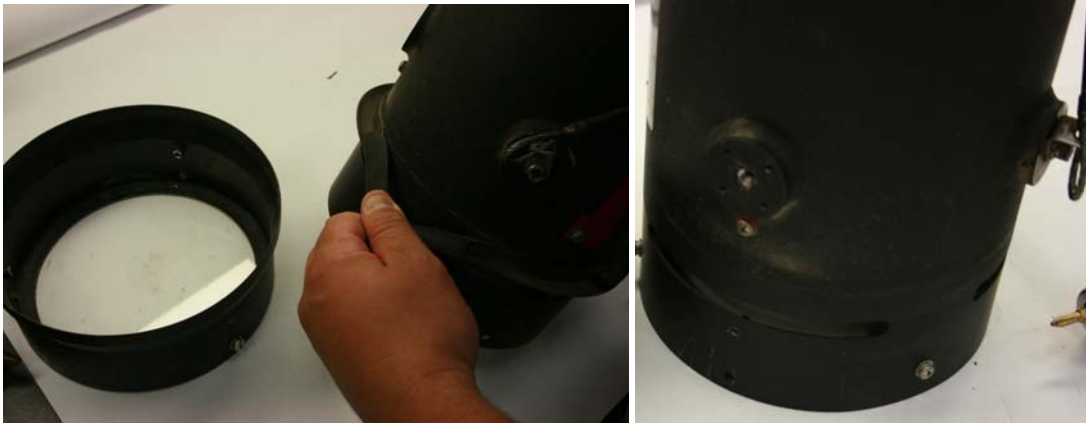
3. Remove the Front Window Assembly. Carefully face the Searchlight face down since arc lamp is exposed. Peel the Baffle away from the Searchlight Housing. Use a razor to remove excess adhesive from the Searchlight Housing then, clean up with isopropyl alcohol (IPA).

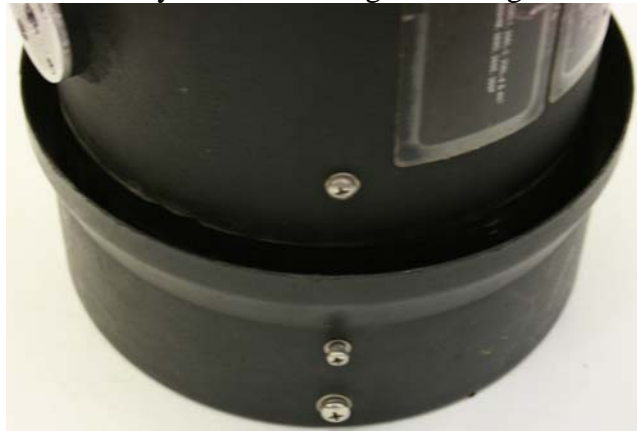
4. Secure the Front Window Assembly to the Searchlight Housing with 3 screws previously removed.

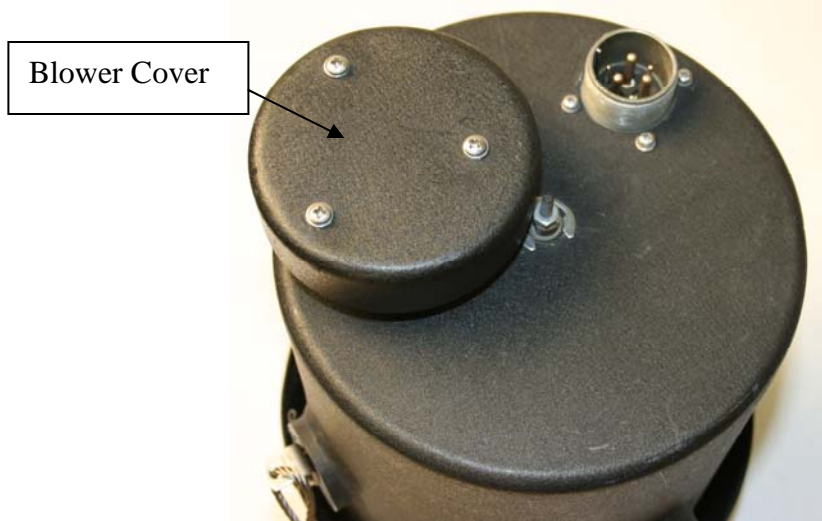
1. Locate and remove the 3 screws fastening the Blower Cover.

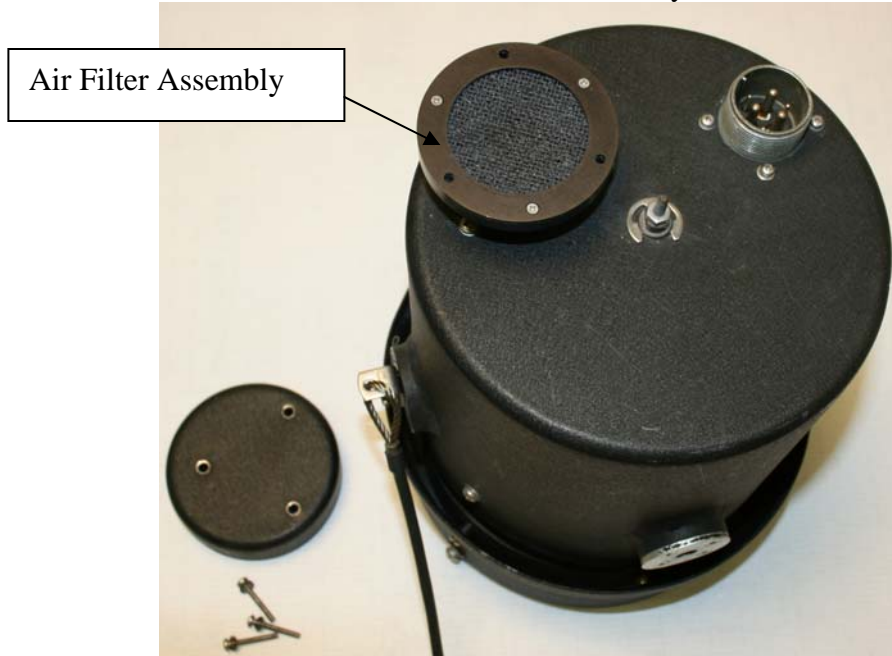
2. Lift off the Blower Cover, and remove the Air Filter Assembly from the Cooling Blower.

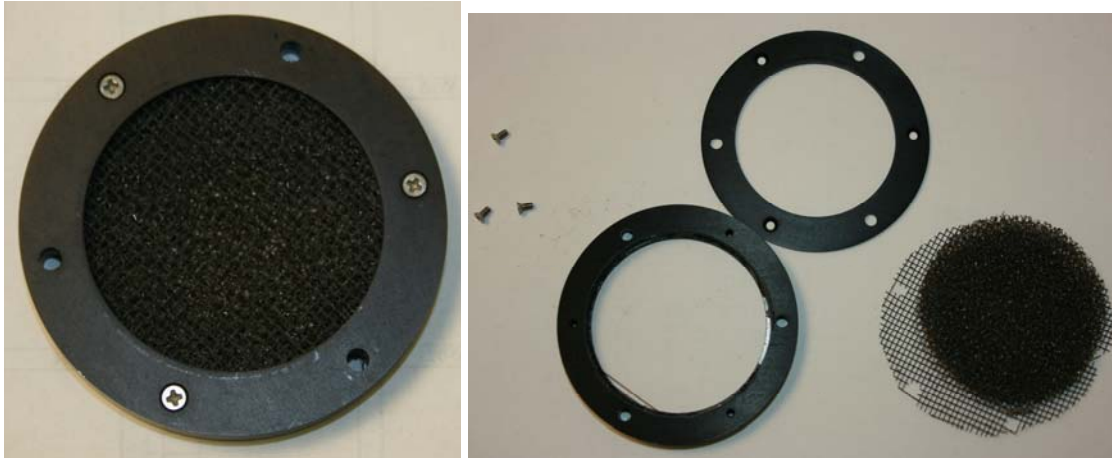
3. On the Air Filter Assembly, remove the 3 screws to separate the Retainer Ring, Screen, and the Air Filter.

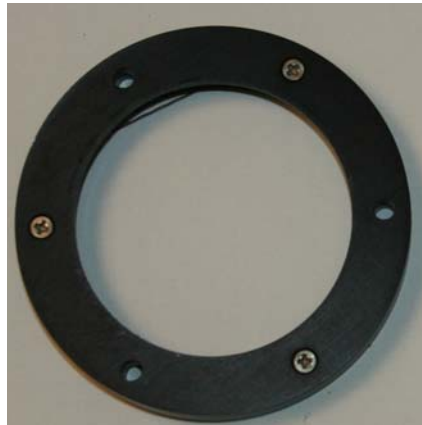
4. Attach the two halves of the Retainer Ring without the Air Filter and screen then, fasten with the 3 screws.

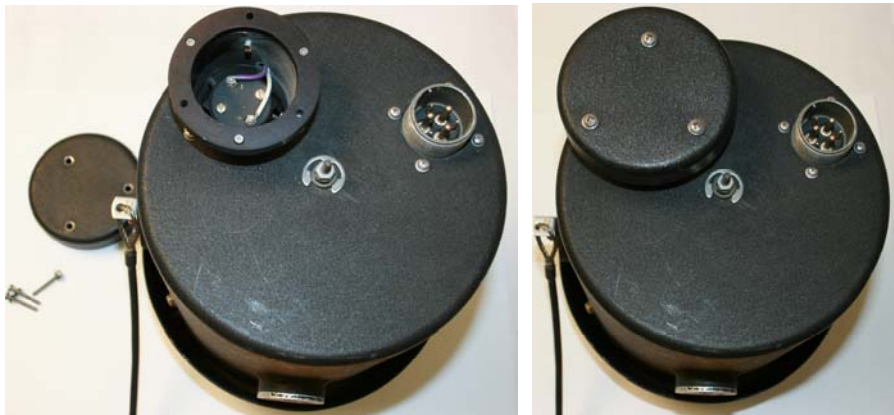
5. Place Retainer Ring on the Cooling Blower and fasten with 3 Blower Cover screws previously removed in step 2.
